FAILURE ANALYSIS ON OPTICAL FIBER ON SWARM FLIGHT PAYLOAD

Frédéric Bourcier⁽¹⁾, Isabelle Fratter⁽¹⁾, Florent Teyssandier⁽¹⁾, Magali Barenes⁽²⁾, Jérémie Dhenin⁽²⁾, Marie Peyriguer⁽²⁾, Romain Petre-Bordenave⁽²⁾,

⁽¹⁾ Centre National d'Etudes Spatiales, 18, avenue Edouard Belin, 31401 Toulouse, Cedex 9, France

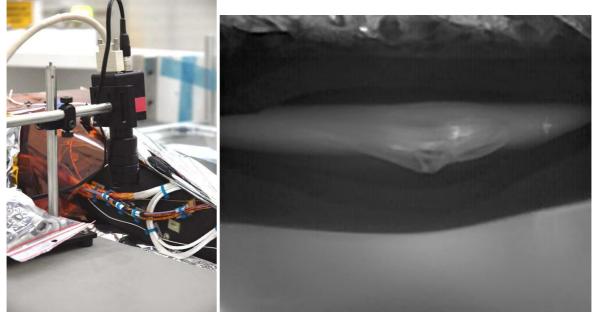
Fig 4: IR imaging of the damaged optical fiber under room light (laser off).

The following pictures "Fig 4" show the IR InGaAs 14 bits camera over "FM1A" optical cable and the IR image with the Viton protection to prevent from bending the optical cable over few centimeters.

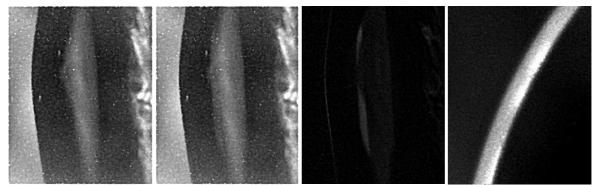
Fig 5: IR long exposure image of the optical fiber: laser off, laser on, and the difference between the two. The last image is the reference for the quantification of the flux taken in the same conditions in our laboratory.

The following infrared pictures (900 – 1700 nm) have been acquired in the same conditions, in the dark, so that they can be directly compared in terms of power, in grey levels. A very small amount of light is escaping from the jacket and can be seen on "Fig 5" on FM1A SWARM instrument. The power of the laser in the optical fiber is 4 times higher (2mW) on the flight model compared to the 460 μ W in our sample at CNES. Anyway, the flux going out of the fiber is insignificant on flight model. The 4th picture "Fig 5" is acquired strictly in the same conditions of integration time, working distance, aperture, cooling and resolution concerning the InGaAs camera. An optical power of 460 μ W is injected in the optical fiber bended with a 6 cm radius of curvature with the same laser source as the flight model. Only the power is 4 times less that the image on flight model. Approximately 5 ppm of light escapes from the jacket, each centimeter, with this radius of curvature. The camera can easily acquire this light with a 350 ms integration time and a subtraction of the dark. It confirms the insignificant amount of light escaping from the jacket on flight model.

To conclude concerning the UV, visual, IR inspection, we know that the optical fiber is not affected by latent cracks. They would involve a measurable loss of light escaping form the core with this InGaAs camera. These cracks have also been reproduced in our laboratory and the amount of light is much more important than what we can see on the flight model.

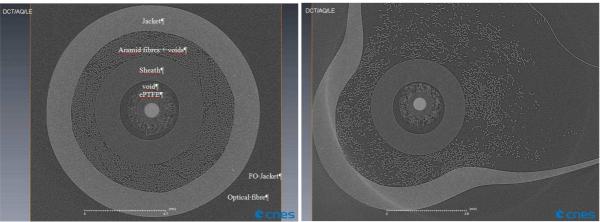
Fig 6: X-ray pictures extracted from tomography videos showing the different protection layers in order to assess the depth of damage

IABG mentioned a possible incident due to the use of a hot air gun too close to the optical fiber. We performed different tests and reproduced the damage. The following tomography "Fig 6" and cross-sections "Fig 7" images show that at these temperatures (about 500° C / 20 seconds) the shape of the sheath is preserved. It means that the optical fiber is still free to move in the sheath and thanks to the Aramid fibers; the excess of heat has been dissipated along the cable. The ePTFE also plays a role in this dissipation.

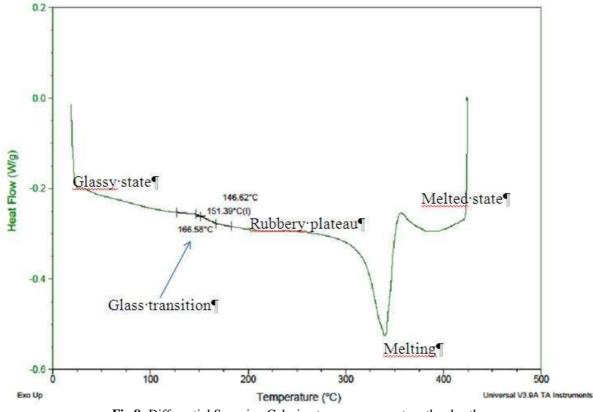
Fig 8: Differential Scanning Calorimetry measurement on the sheath

In addition, differential Scanning Calorimetry measurement on the sheath "Fig 8" showed that the glass transition temperature at a rather high temperature is the same for the heated and the unheated overall optical cable.
